Finishing the Walls and Roof, 1834-1835

Source: *The First Mormon Temple: Design, Construction, and Historic Context of the Kirtland Temple*

Finishing the Walls and Roof, 1834–1835

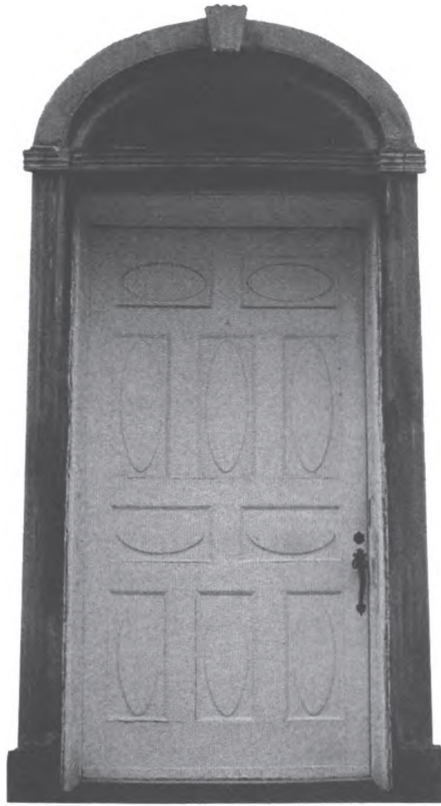
4-1. Raised elliptical panels on entrance door, Kirtland Temple. Elliptical panels are a feature found in Canada (fig. 4-2) but not in Ohio or New England. Photo by author.

church of L'Assomption, Quebec (fig. 4-2).¹² The use of a Canadian building motif in the Kirtland Temple can probably be attributed to Artemus Millett.

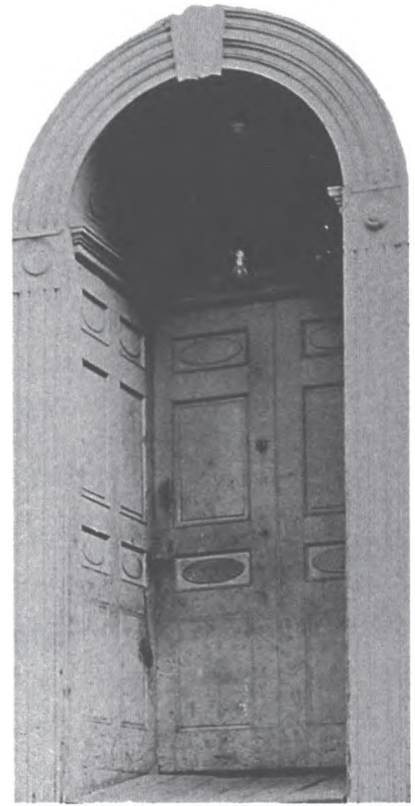
4-2. Detail of entrance door, L'Assomption, Quebec, from Frary, *Early American Doorways*, 1937. Note the raised elliptical panels.

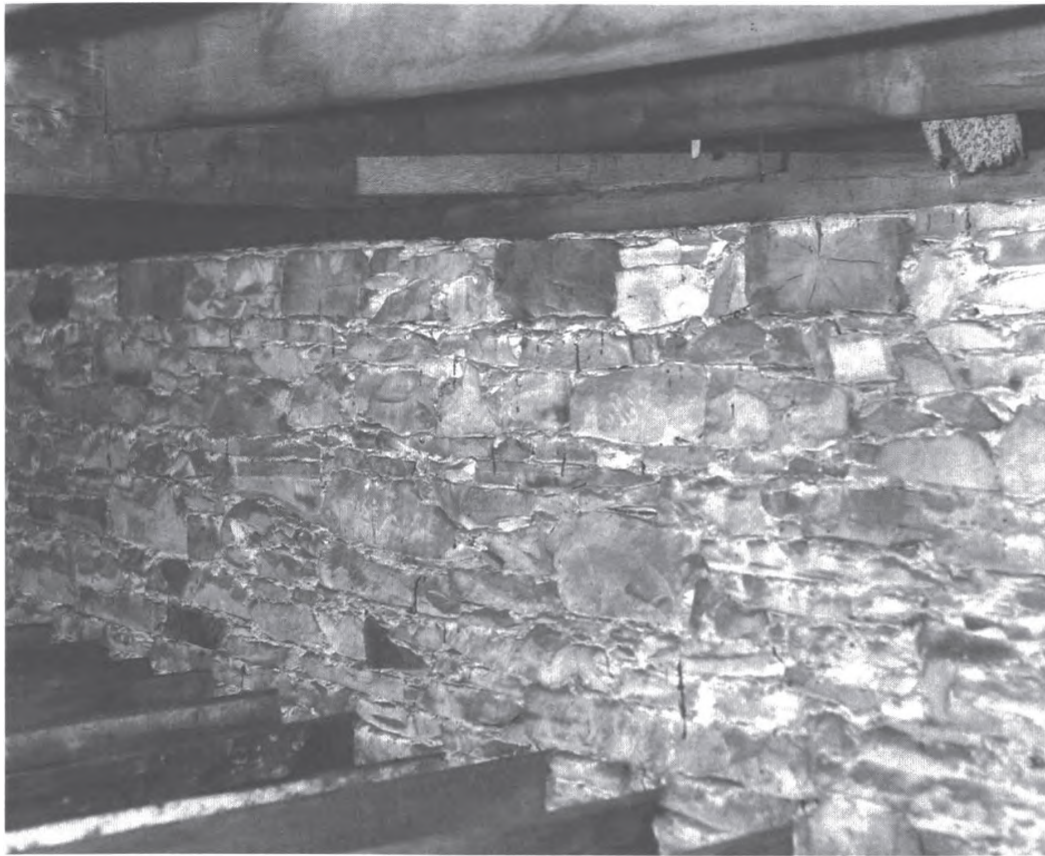
4-3. Masonry wall above the upper-court ceiling and below the attic-office floor, one of the few places in the temple where the roughly shaped sandstone blocks can be seen.

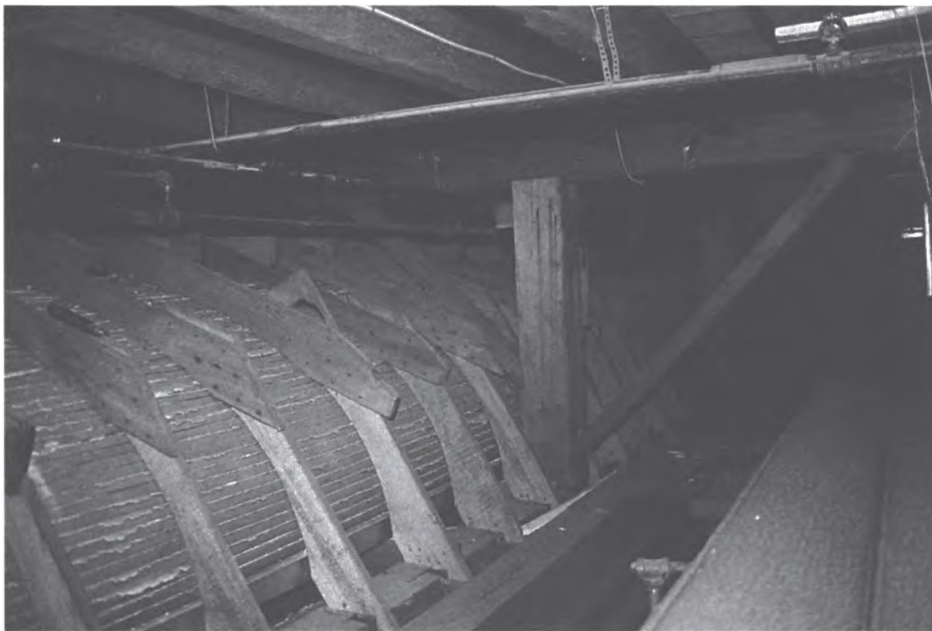
4-4. Detail of structure showing knee braces supporting the girders under the upper-court floor. The photograph was taken in the interstitial space between the ceiling of the lower court and the floor of the upper court. Note the framing for the elliptical ceiling on the left of the photograph. Modern items include stacks of upholstered pads for the wooden benches (lower right), piping for the sprinkler system, and an iron tie rod that was inserted to keep the west wall of the temple from leaning outward.

Millett's first critical decision regarding these girders was to make them continuous. Like the girders supporting the lower-court floor, Millett's girders span fifty-five feet between the masonry walls and are supported by wooden columns at two intermediate locations. The locations of the supports result in spans of about fifteen, twenty-five, then fifteen feet. Although three separate girders would have been easier to find, prepare, transport, and hoist into place, discontinuous girders would never have developed sufficient strength to support the expected loads. Continuous girders resist bending not only at the center of the span, but also at the supports. This resistance spreads the bending stresses across a greater portion of the girder, thereby increasing the load it can safely carry. In addition, the upper girders are fitted at the interior supports with knee braces (fig. 4-4) that significantly

reduce the high stresses in the girders. These factors bring the girders very close to modern code requirements.

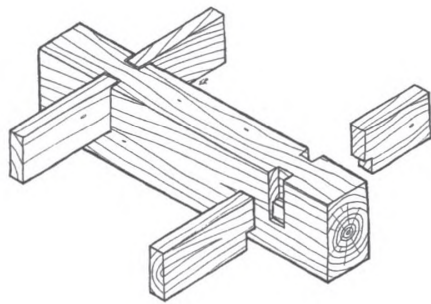
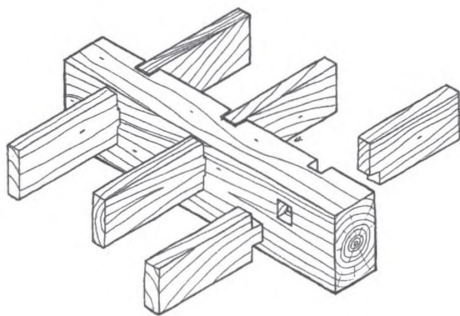
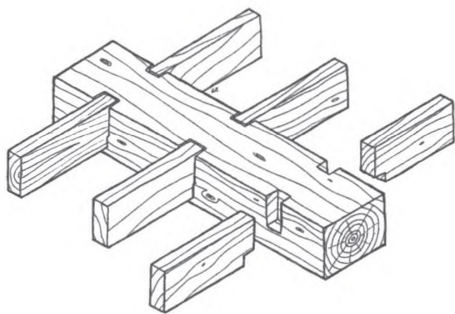
4-5. Detail of mortise-and-tenon joints for the lower-court, upper-court, and attic floors. Note that the tenons of the joists on the east end are extremely small. Also note that the mortises of the attic-office floor are “shouldered”—they have a second, shallow mortise intended to support the joist across its full depth.

The considerable variation in mortise and tenon details throughout the temple (fig. 4-5) is a direct result of the work force changing during construction.

The girder-joist connection on the lower-court floor is a mortise cut into the upper half of the girder. This technique was common because the tops of girders are generally in compression. If a tightly fitting tenon is inserted into a mortise in compression, the girder is not weakened substantially, while the tenon is tightly bound in the mortise. However, the multiple-span, continuous girders of the temple have tension areas on the tops of girders at the intermediate supports, and mortises in these areas significantly weaken the girders. Bump and Cahoon, the craftsmen who likely placed these girders, did not make any adjustments to the mortise and tenon system near these intermediate supports, nor did the other craftsmen working on the upper girders. Such a level of structural understanding was well beyond the capabilities of common builders in the 1830s.

The depth of the mortises in the temple's lower girders is roughly equal to half the depth of the joist. This reduction in the cross section of the joist at the connection creates high stresses in the joist at the bottom of the tenon. Several joists in the temple have "failed" by splitting along the length of

the joist from tenon base to tenon base. Such failures have appeared particularly in the vestibule area, where large crowds are most likely to congregate. Collapse has not occurred because the load has been distributed to adjacent joists by the thick floorboards, but joists weakened by splitting are a structural concern in the temple at the time of this writing. Fortunately, this problem can be remedied simply by inserting new joists next to the failed ones and connecting the new members to the girders by using metal joist hangers nailed into the girders.

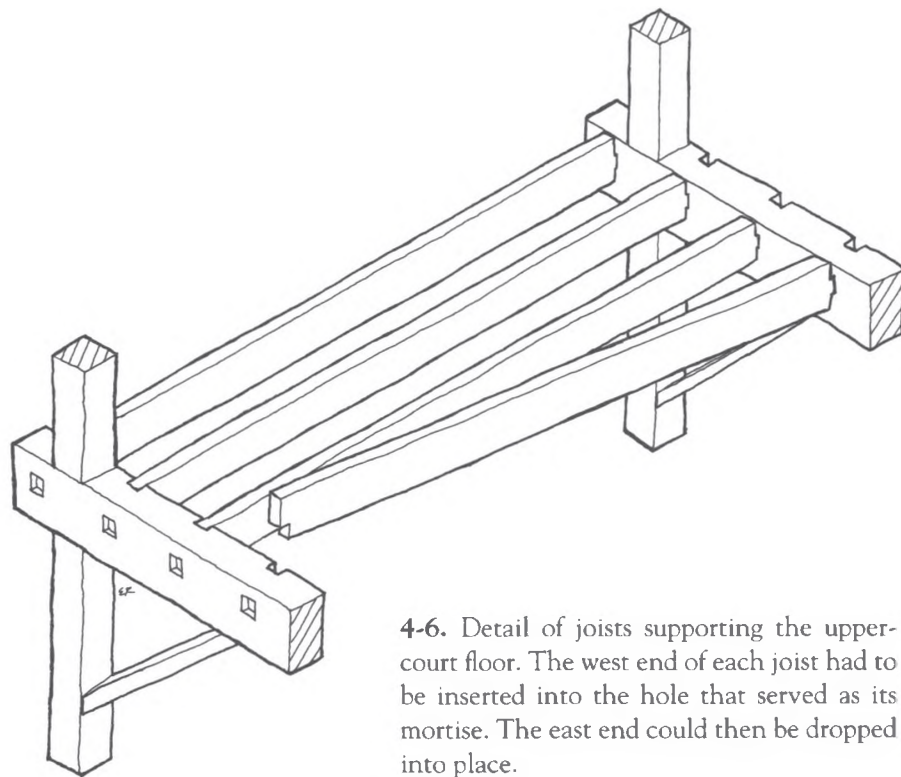
4-6. Detail of joists supporting the upper-court floor. The west end of each joist had to be inserted into the hole that served as its mortise. The east end could then be dropped into place.

Although the main girders supporting the two upper levels are of like material and are similarly tooled with adzes, the mortises cut into the girders for the joists are different. The girders supporting the upper-court floor have mortises cut to accept joist tenons at eighteen-inch intervals like those of the lower-court floor. Most mortises are slots cut into the girder so that the tenons of the joist are dropped into the mortises from above. However, each upper-court girder is cut with a three-inch mortise on its east side that is not an open slot but rather a hole cut into the side of the girder. Thus the tenon can be inserted into the girder only from the side. On the opposite side of the girder is a more conventional 5½"-deep slotted mortise. With this design, the west end of the joist had to be inserted into the mortise and then the east end dropped into place (fig. 4-6).

Unfortunately, the three-inch tenon on the west side of the joist is woefully inadequate to transfer the weight borne by the joist to the girder. Failure has not occurred because the upper court has not received the intensive use the lower court has, and—at least since their installation—the pews have prevented tightly packed concentrations

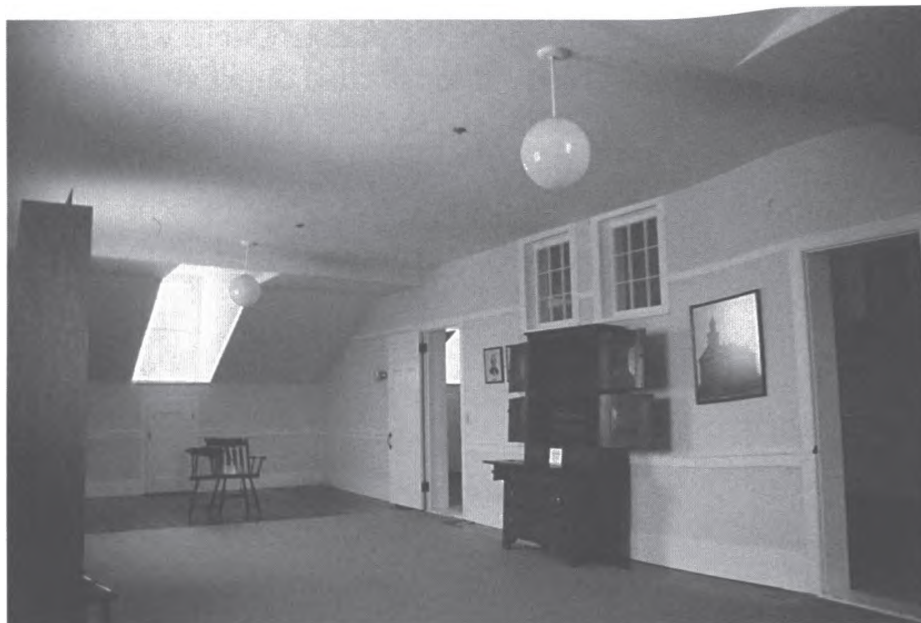
4-7. Western office used by Joseph Smith, Kirtland Temple. The doors and windows on the interior wall are placed between the posts and diagonals of the roof truss.

Begun in February 1835, the roof structure uses a variation of the king-post truss (fig. 3-10 and glossary) and is from the same wood species, probably black walnut, that is used in the timbers in the lower court. Coinciding with the bays of the supporting columns, the trusses are contained in the walls that divide the attic into five separate offices. Although not mentioned in the specifications for the Independence Temple, the attic offices take advantage of the considerable space under the roof and between the roof trusses (fig. 4-7). No corridor

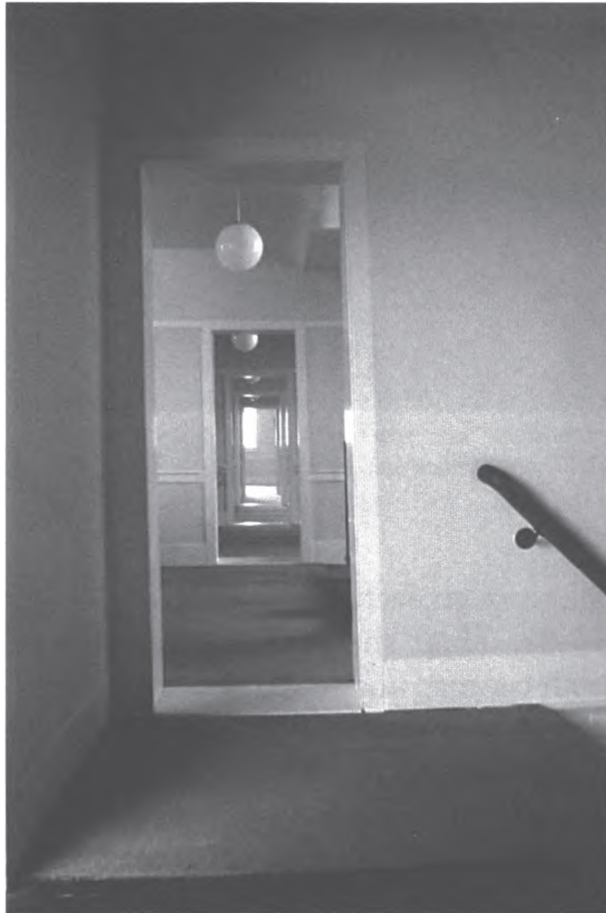
4-8. Doorways leading through the attic offices, photographed from the top of the vestibule staircase. The staircase is aligned to end where the line of doorways starts.

joins the offices; rather, one has to walk through each of the offices in turn to access the westernmost office (fig. 4-8). This “shotgun” arrangement of spaces was not unusual in the nineteenth century, and it allowed for the maximum amount of floor space and light in each of the rooms. Joseph Smith and his counselors probably did not anticipate the large volume of space available under the roof since their previous experience was with smaller residential structures. The five large attic offices provided more than adequate space for the relatively small Church leadership, and plans for a separate structure for printing and other office functions were dropped (see D&C 94).
